# Manhole Inspection Summary

Manhole # S25YY1001MH

**Location** Address: **ROLAND AVE**

Cross Street: **NORTHERN PKWY**

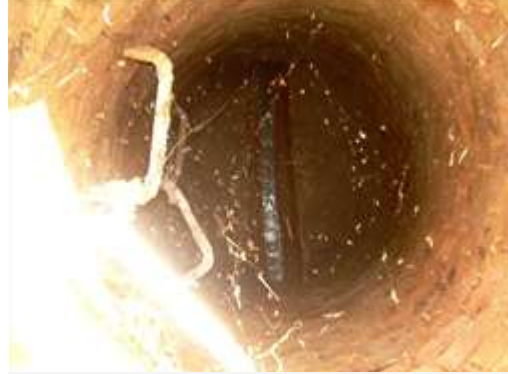
Top View

Corroded steps. Evidence of surcharge - Bench debris.

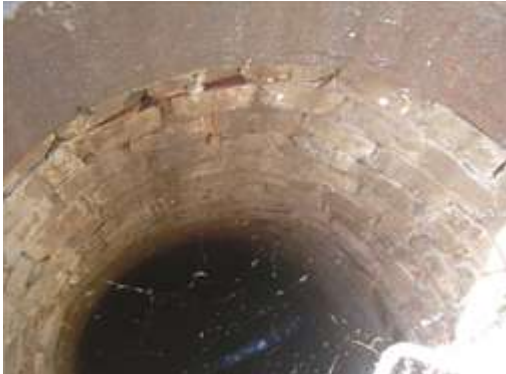
Defect

**Frame** Offset: **1** (in.) Condition: ☐ Sound ☐ Cracked ☒ **Leaks**

Condition: ☐ Sound ☐ Cracked ☐ Root Intrusion ☐ Loose Brick ☒ **Deteriorated**

Infiltration: ☐ None ☒ **Joint** ☐ Cracks ☐ Mortar ☐ Roots ☒ **Wall**

Infiltration: ☐ None ☐ Joint ☐ Cracks ☒ **Mortar** ☐ Roots ☒ **Wall**

Frame leaks. Adjustment and Corbel deterioration and infiltration.

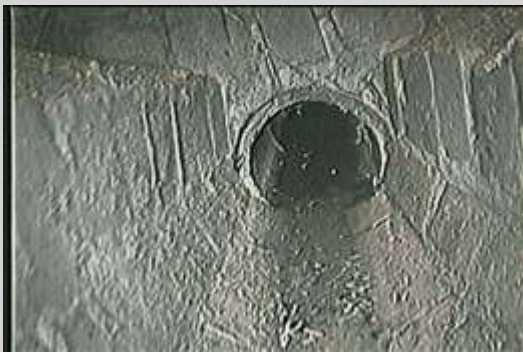
### 6 in. Circular Gravity Sewer Pipe Out @ 12 O'Clock

Infiltration: **Evidence** Pipe Seal Cond: **Unknown**

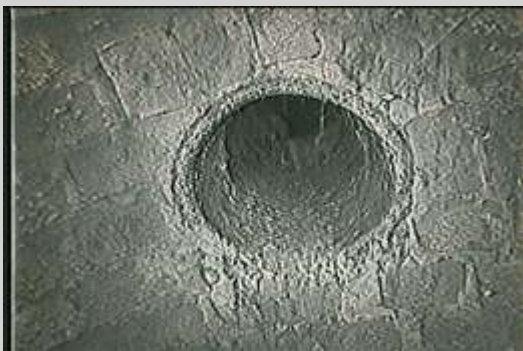
### 8 in. Circular Gravity Sewer Pipe In @ 6 O'Clock

Infiltration: **Evidence** Pipe Seal Cond: **Roots**

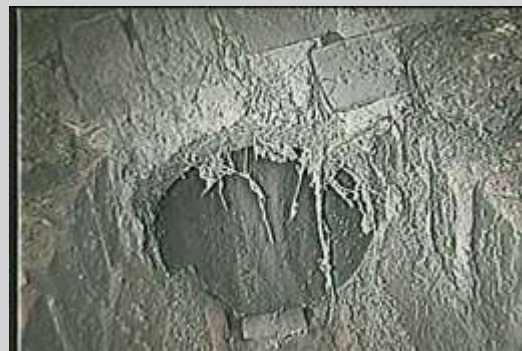
### Drop In @ 6 O'Clock

Condition: ☐ Sound ☐ Cracked ☒ **Root Intrusion** ☐ Loose Brick ☒ **Deteriorated**

Infiltration: ☐ None ☐ Joint ☐ Cracks ☒ **Mortar** ☒ **Roots** ☒ **Wall**

Barrel deterioration, root intrusion and infiltration. Channel root intrusion.
